LuK Service Info

Clutch actuation force too high

Incorrect assignment of the clutch results in a malfunction

Model: Atego I

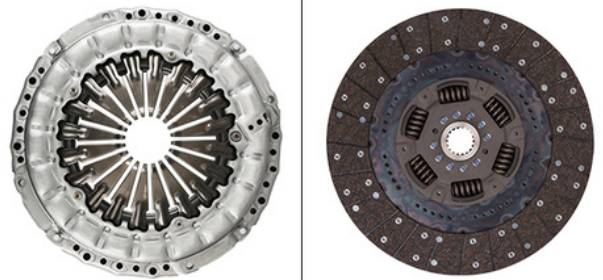
Figure 1: Clutch set 640 3014 09 (for vehicles with a clutch booster)

There are two versions of the clutch actuator on the manual gearboxes of the vehicle model specified above. There are versions with and without a clutch booster. For models with a clutch booster, clutch kit 640 3014 09 must be used. For models without a clutch booster, clutch kit 640 3111 09 must be used.

Clutch kit 640 3014 09 (for models with a clutch booster) must not be installed in a vehicle without a clutch booster. In this case, the clutch cannot be actuated or will be very difficult to actuate and the vehicle cannot be driven.

To avoid incorrect assignment, information (for vehicles with/without a clutch booster) is included for the relevant clutch sets in the catalog. These make clear identification possible.
