Anti-roll bar kits with mounts and connecting rods

Everything for repairs!

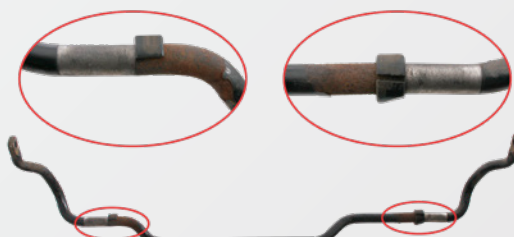
Fig.1

Road debris, road salt and other external factors are frequent causes of damage to the anti-roll bar's coating (see Fig. 1). The worn coating of the anti-roll bar often gives rise to squeaking noises.

When the anti roll paint protection is damaged around the mounting points, always replace the anti-roll bar along with the rubber mounts.
