# VKBA 3608

## Technical Bulletin – September 2015

Renault: Laguna II , Laguna II Grandtour, Clio II ---> 2000-11-01

Mandatory placement of the ABS sensor holder in the center of the knuckle

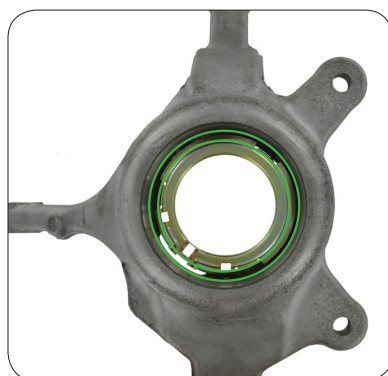
picture 1

### Correct mounting

The ABS sensor holder is placed centered, cannot damage the bearing and the ABS sensor will generate an accurate signal.

When mounting the ABS sensor holder, it is mandatory to place it in the center of the knuckle, before pressing in the bearing (see *picture 1*). A wrong position of the holder causes an abrasion of the ABS sealing and leads to premature bearing failure due to the deformation of the ABS holder (see *picture 2*).
